# Fisher and Paykel Aquasmart Washing Machine Suspension Rods Replacement

Kept getting an overbalance fault. Very heavy knocking sound during the rinse cycle.

Written By: James

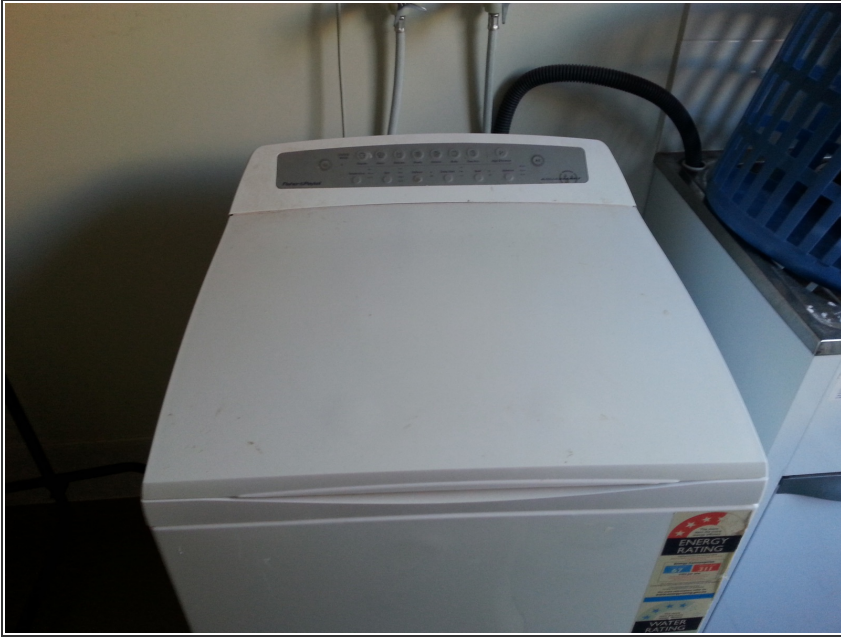
## Step 1 — Getting Started

- First step is to disconnect all the hoses at the back and then move it to place where you have some room to work.

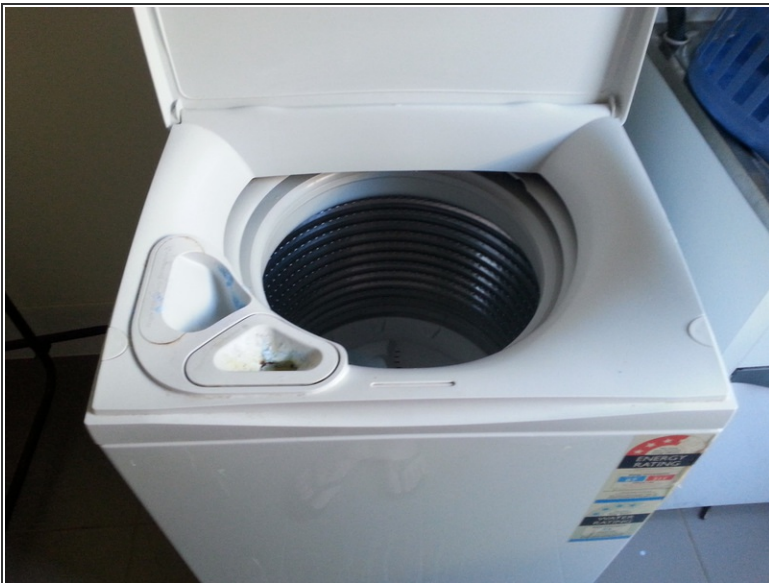
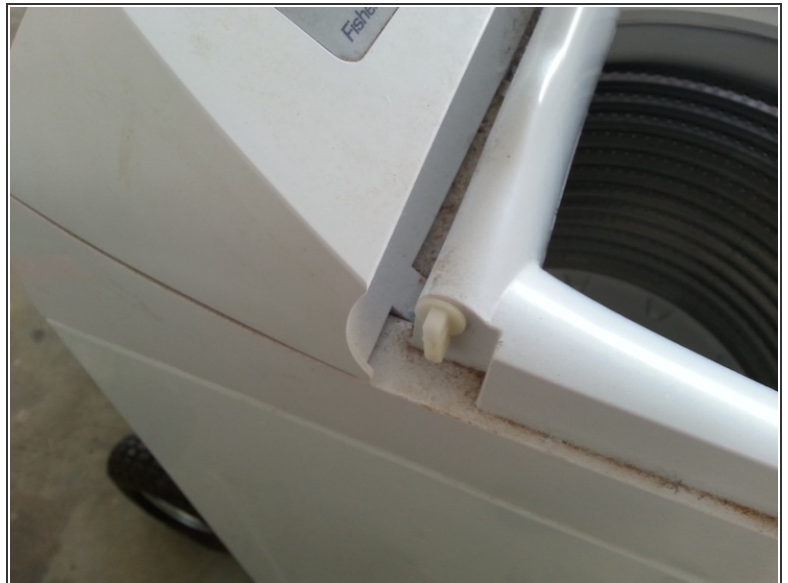
## Step 2 — Remove the lid

- Removing the lid is the easiest part. Just push back until the lid is perpendicular with the top of the machine, then lift upwards and it will release.

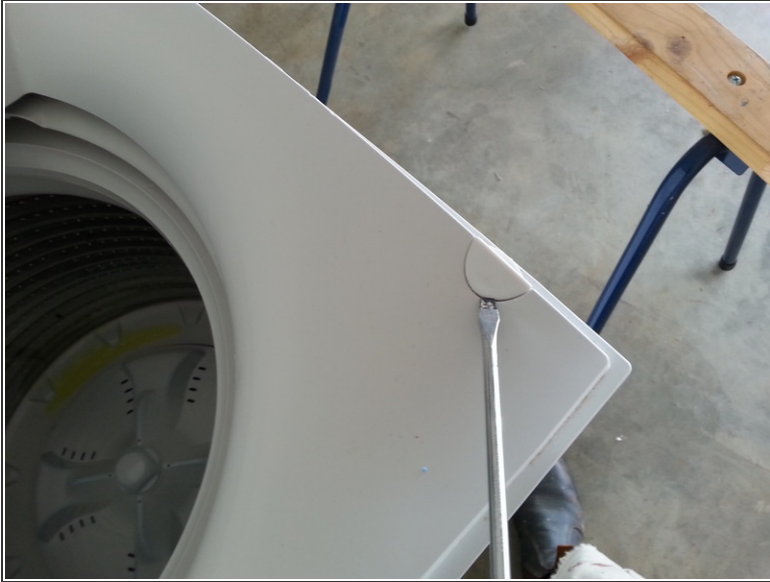
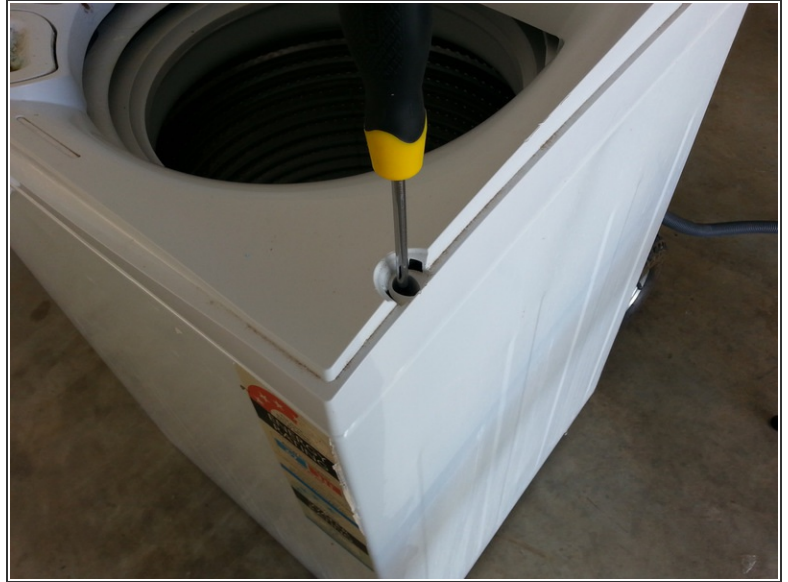
### Step 3 — Unfasten the plastic cover

- Simply pry off the plastic screw covers then unscrew the two forward screws. Note there is no need to remove the cover, just tilt it backwards on its hinge to gain access. Be careful with hoses and electrical wires at the back of the cover.

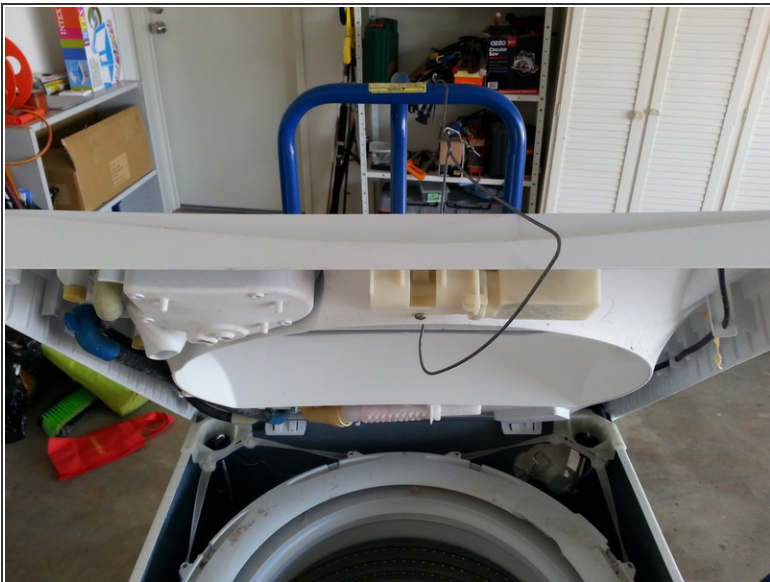
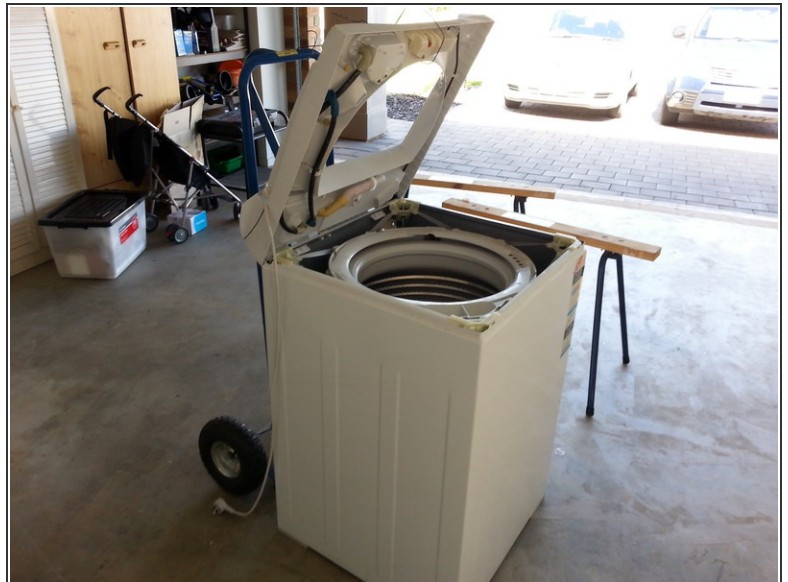
### Step 4 — Suspend the cover out of the way

- I used an old coat hanger to suspend the plastic cover out of the way by hooking it onto the trolley that I used to move the washing machine. This gives you access to the 4 rubber straps and 4 suspension rods.

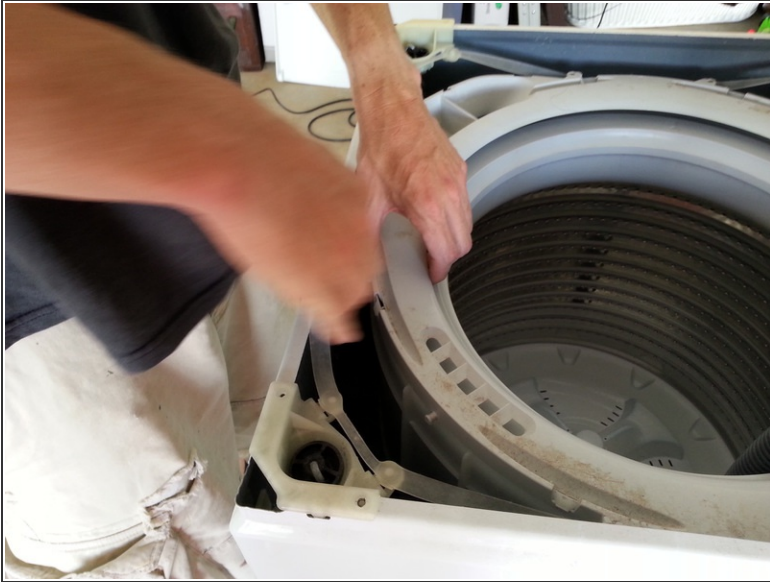
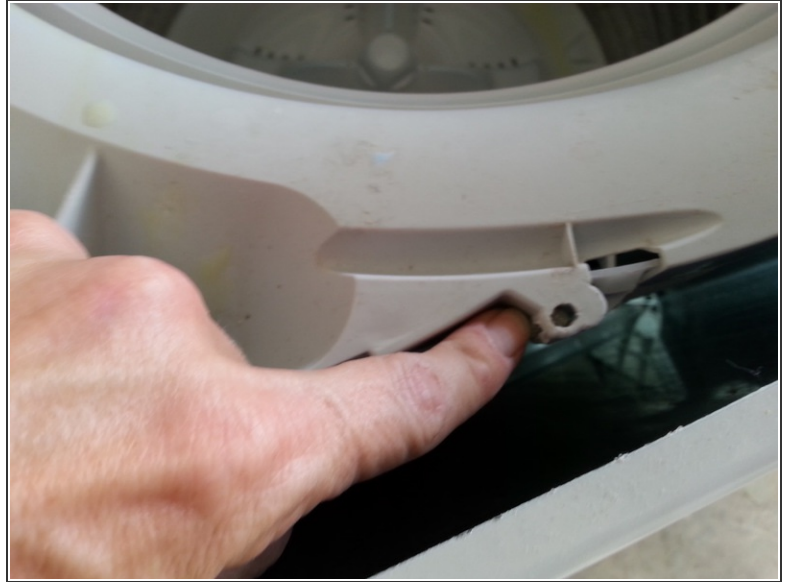
## Step 5 — Replace the Rubber Hanger Straps

- You will see there are four rubber straps, one in each corner. I decided to replace these as well just to be on the safe side. When the old and new rubber straps were placed next to each other there was a significant difference in length. Just pull them straight off.

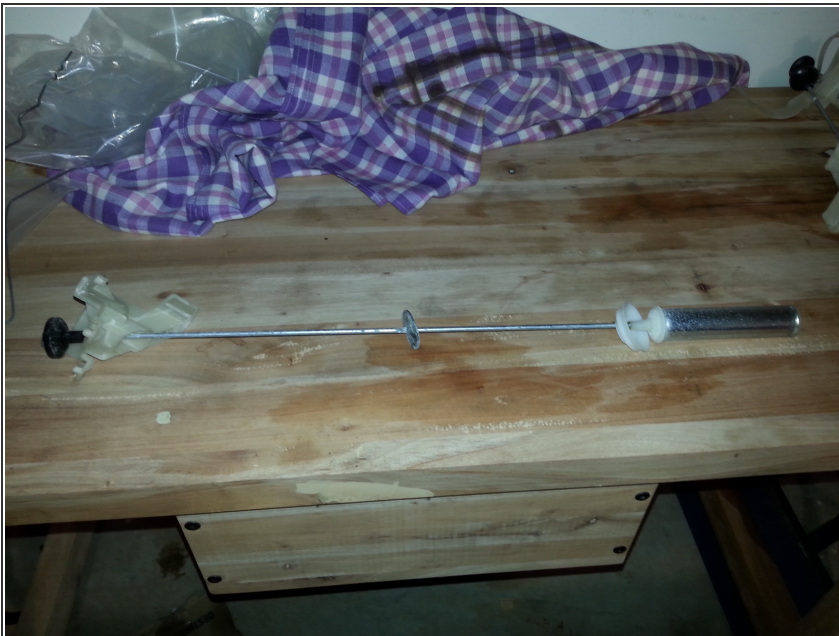
## Step 6 — Removing the Suspension Rod

- The metal cylinder down the end is full of oil which leaks out over time. When I removed this one it was very greasy. Note the rear right rod has a bend in it and is unique to the other three. Ensure you identify this one first prior to commencing.

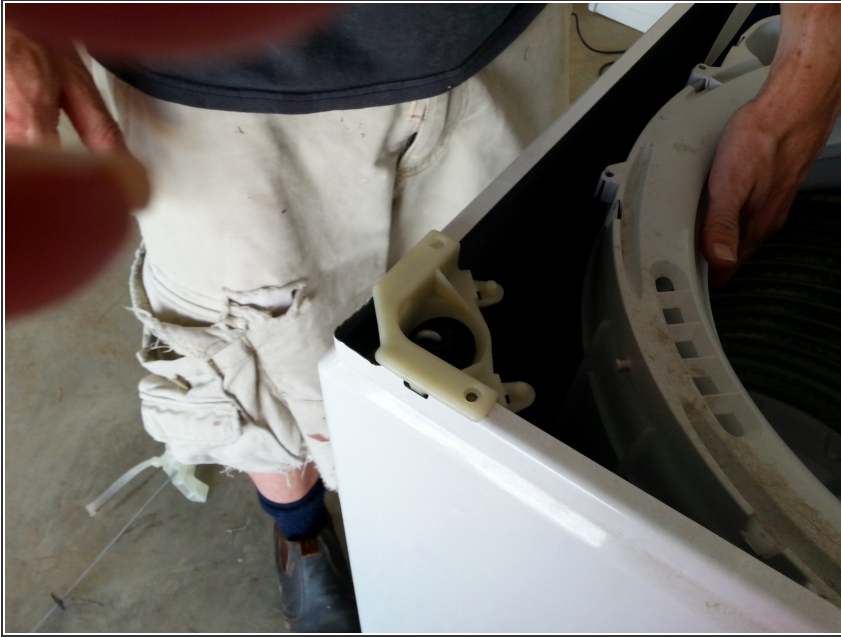
## Step 7 — Lift out the Suspension Rods

- Place your left hand under the drum rim and support it. Remove and replace one rod at a time. You don't want the weight of the drum on the motor and pump below as you may break something underneath. By replacing them one at a time, the other three can help support the weight of the drum.

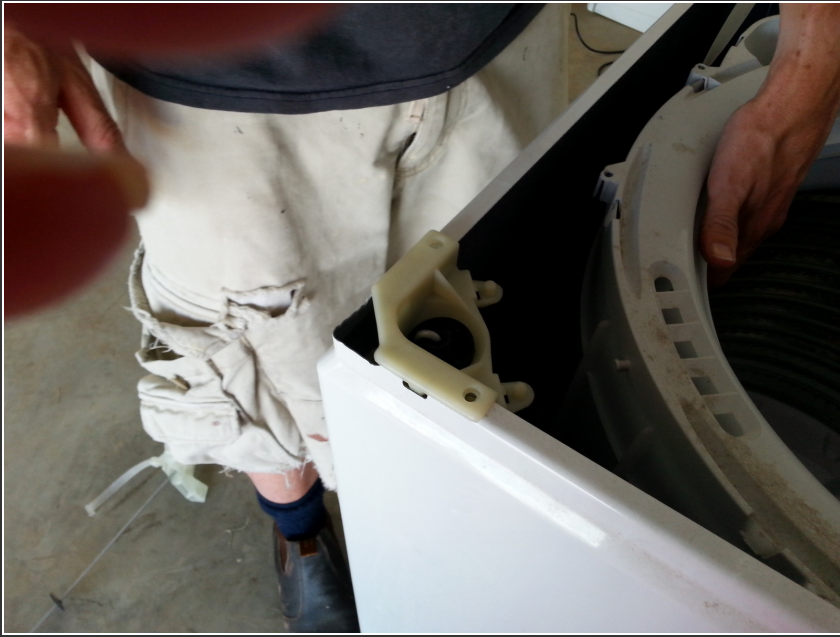
## Step 8 — Removing the Suspension Rods

- To remove the rods lift the plastic hanger off the chassis and then jiggle the bottom part of the rod out of the slotted holder. There are no fasteners holding the rods in place. Its just the weight of the drum holding them in place.

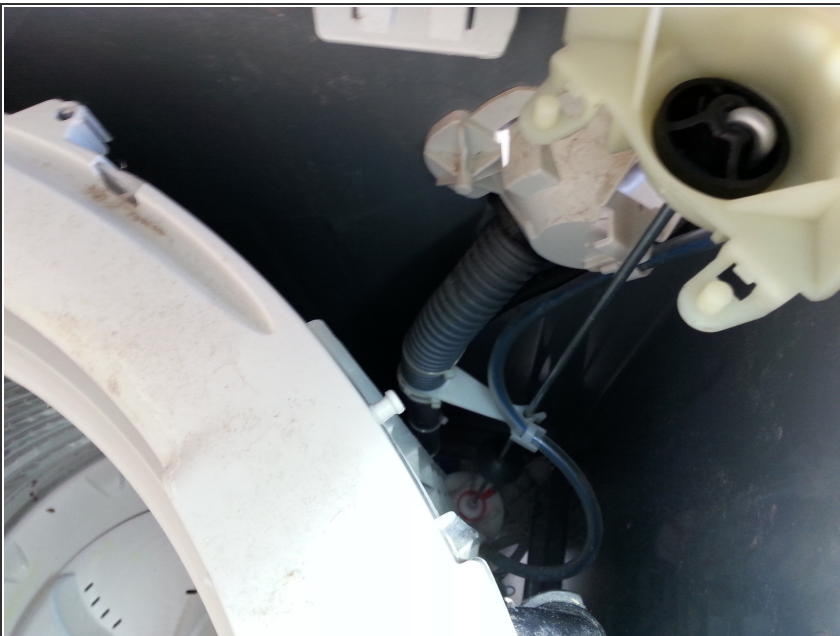
## Step 9 — The Rear Right Rod is Different to the Others

- There is a clip half way down the rear right rod that needs to be undone. You also need to move the hoses and electrical looms out from under the plastic hanger prior to removing the rod. To remove the rods lift the plastic hanger off the chassis and then jiggle the bottom part of the rod out of the slotted holder.

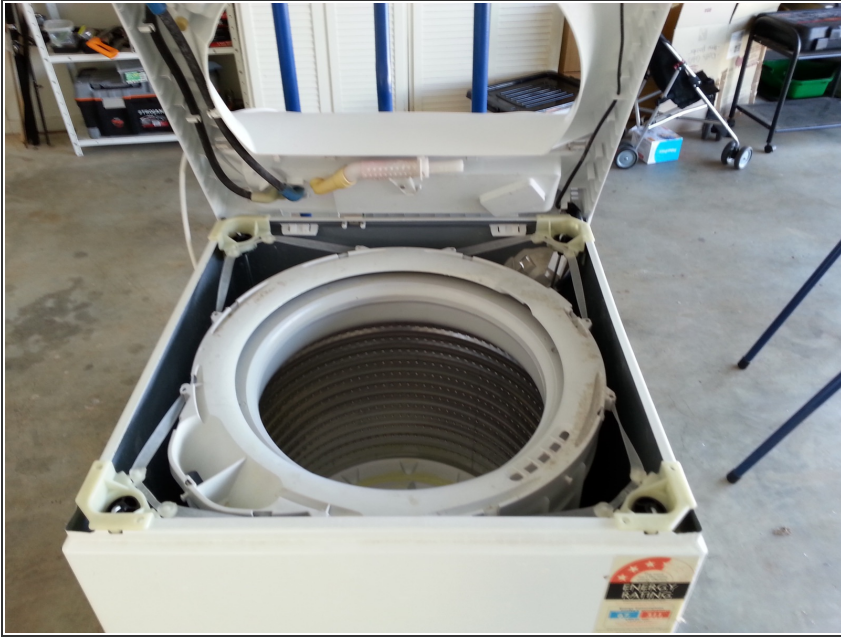
## Step 10 — Reassembly

- Once you have replaced all of the suspension rods and rubber straps you can reassemble the washing machine cover and lid. Then you are finished. My washing machine ran beautifully after I completed this repair. Best of luck to you.
